NRL/MR/6180--99-8423

Thermal Insult Produced by the Residual Liquid Fuel in a Missile Hit Scenario

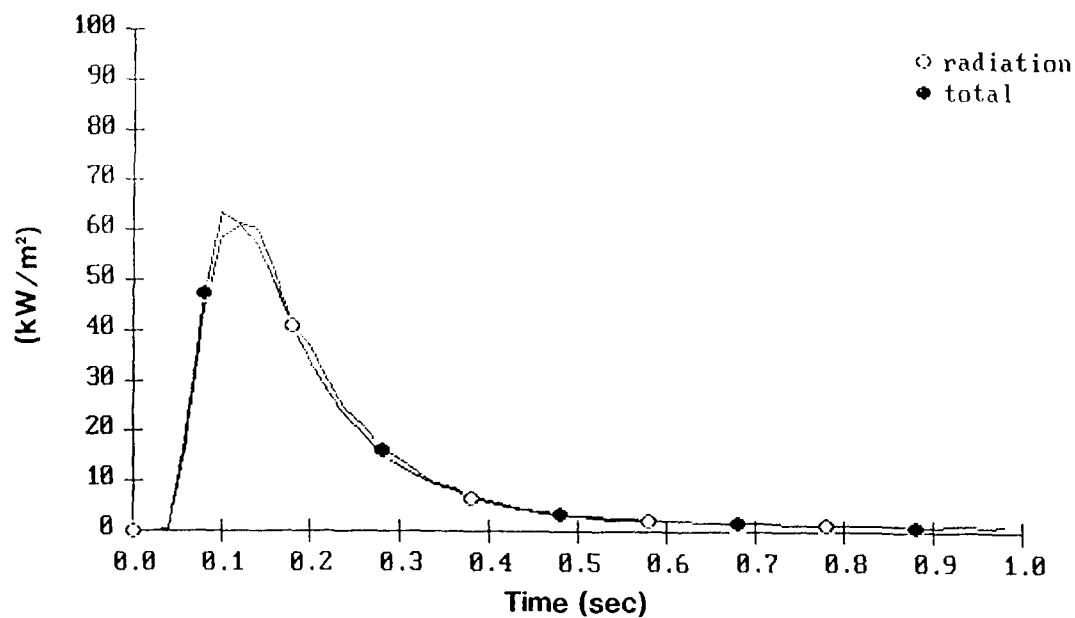
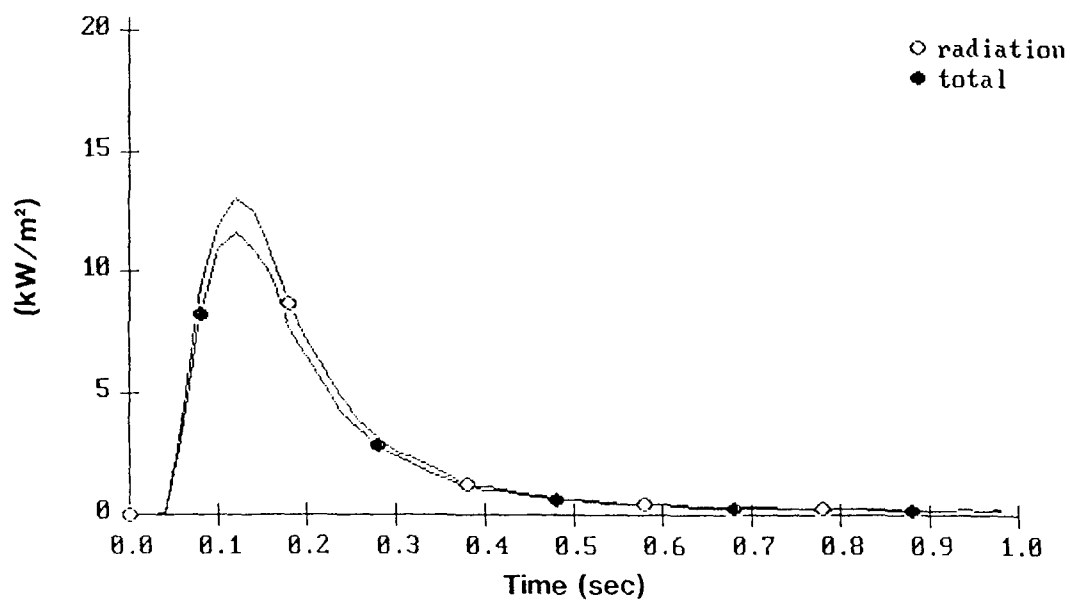
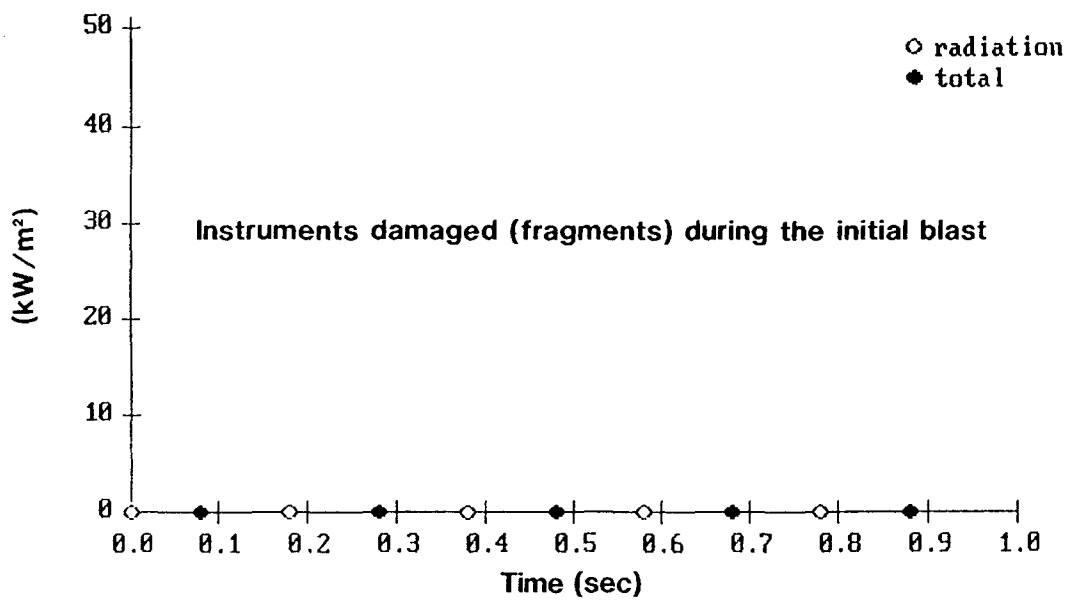
The radiant and total heat flux measurements were also dramatically higher for the second test (compare Figs. 11a-c and 19a-c). The maximum exposures were measured on the starboard side of the ship with both the radiation and total heat flux levels reaching values over 60 kW/m^2 (Fig. 19a). This increase was well over an order of magnitude greater than those measured during the first test. The exposures in the center of the compartment were also observed to increase a factor or two from the first test (averaged from 6.5 kW/m^2 to 12.5 kW/m^2) (see Fig. 19b). Although the heat fluxes recorded in Martest 204 were higher than in Martest 203 and of longer

Fig. 19a - Fire compartment exposures (starboard) Test #2

Fig. 19b - Fire compartment exposures (center) Test #2

Fig. 19c - Fire compartment exposures (port) Test #2

duration, they were still below the threshold required for ignition of Class A materials. For example, the peak value of 60 kW/m² in Fig. 19 would have to be sustained for 2.5 seconds in order to cause ignition compared with only 0.05 seconds in Fig. 19a.

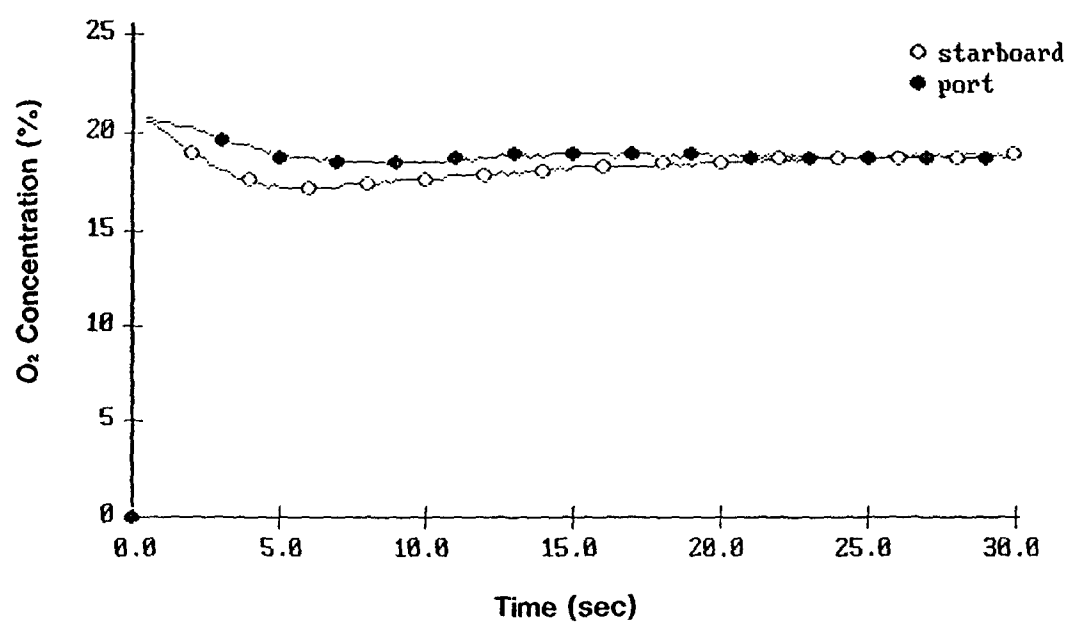
Fig. 20 - Fire compartment oxygen concentrations Test #2

The oxygen concentrations were measured to be lower on the starboard side of the compartment than on the port (Fig. 20). The starboard oxygen concentration was observed to drop to 17% as compared to 18.5% on the port side of the ship. The localized oxygen depletion was the result of liquid fuel burning inside the ship. Although these concentrations were lower than those of the previous test, there was still enough oxygen remaining in the compartment to support ignition and combustion of Class A materials.

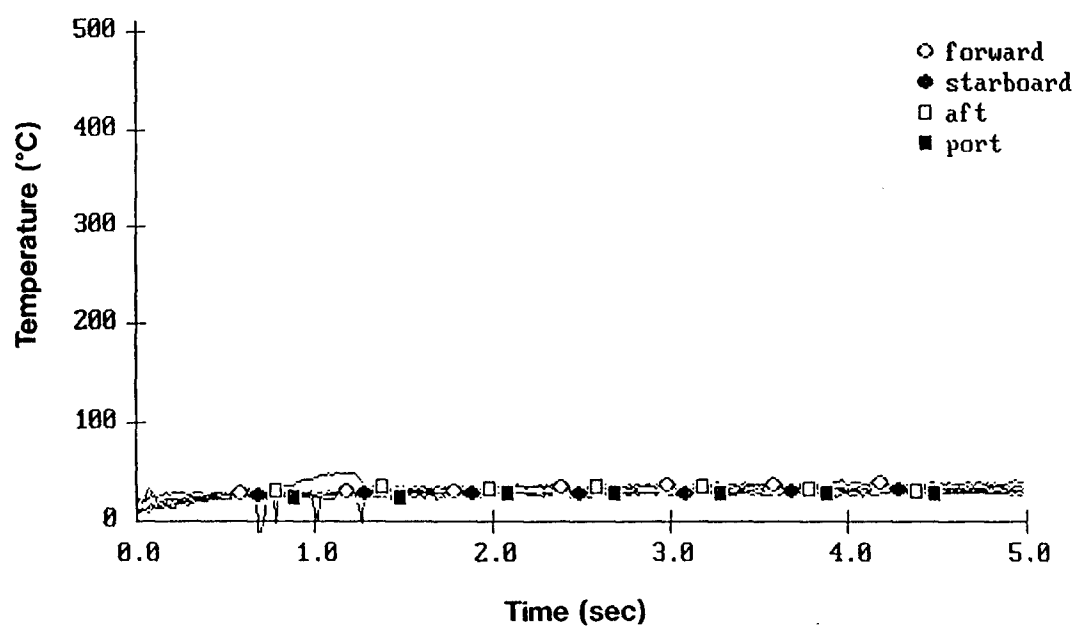
Fig. 21 - Ignition indicator temperatures (all) Test #2

Although the intensity of the thermal pulse recorded in the second test (Martest 204) was substantially greater than in the first (Martest 203), the ignition indicators still did not ignite (see Fig. 21). As in the first test, the thermal pulse was of too short a duration to cause ignition of the paper ignition indicators even though there was evidence of combustion of liquid fuel in the compartment.

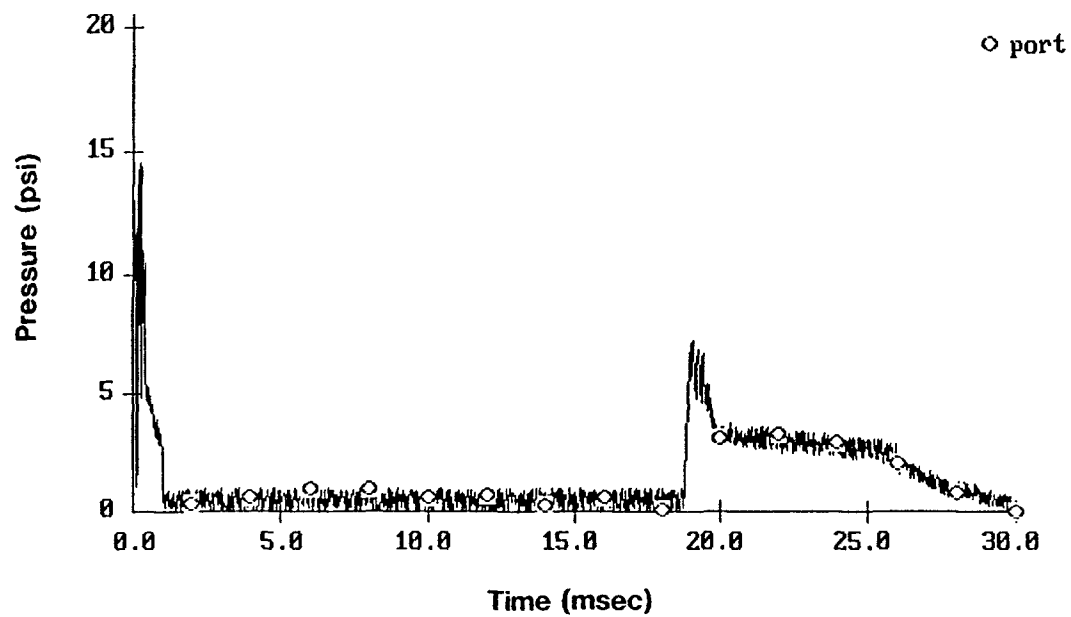
Fig. 22 - Fire compartment pressures in Martest 204

The combustion of the liquid fuel had very little effect on the shape of the pressure curve. A comparison of the pressure readings for Martests 203 and 204 (Figs. 14 and 22) shows that the peak pressures were approximately the same in both tests (8 psi in Martest 203 and 7 psi in Martest 204), but the pressure was drawn out for an additional 5 ms in Martest 204. The shape of the pressure pulse indicates an initial spike in pressure due to the hull penetration and then a sustained pressure as the fuel/air cloud ignited. The only explanation for the similarity in magnitude between the two tests was the presence of the opening produced during the first test which may have served to vent a portion of the pressure pulse in the second test.
